# Extensive review of the national boundary between Sweden and Norway

Dan NORIN, Sweden, Anders ØSTERAAS, Norway, Martin LIDBERG, Sweden,  
Tor Erik BAKKE, Norway, Mikael LILJE, Sweden

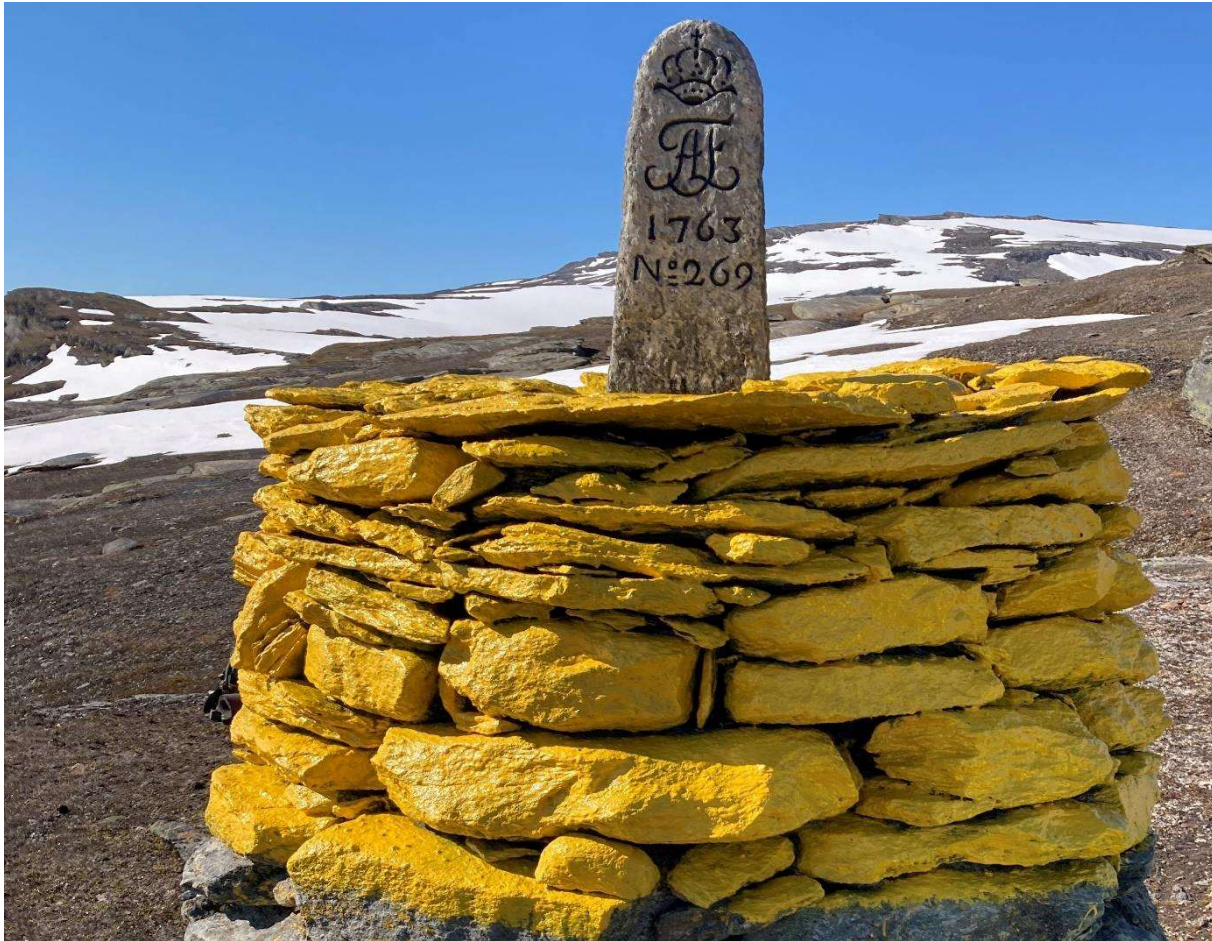
**Figure 1:** The main part of those boundary markers that were erected during the 18th century consists of about 1.5 metres high stone cairns with flat stones with engraved royal monograms. The Swedish side bear the monogram of King Adolf Fredrik, as here on boundary marker no 269.

The remaining part of the boundary is dealt with in the detailed Strömstad treaty from 1751, which also is a treaty between Sweden and Denmark-Norway. This treaty, incidentally, also deals with a large part of the current national boundary between Norway and Finland. During the boundary demarcation that followed 1752–1766, 349 boundary markers were erected. The main part of these markers consists of about 1.5 metres high stone cairns. Centred in the cairns are flat stones vertically erected, bearing engraved royal monograms of the Swedish King Adolf Fredrik and the Danish-Norwegian Kings Fredrik V (monograms from 1752–1765) and Christian VII (monograms from 1766), see Figure 1.

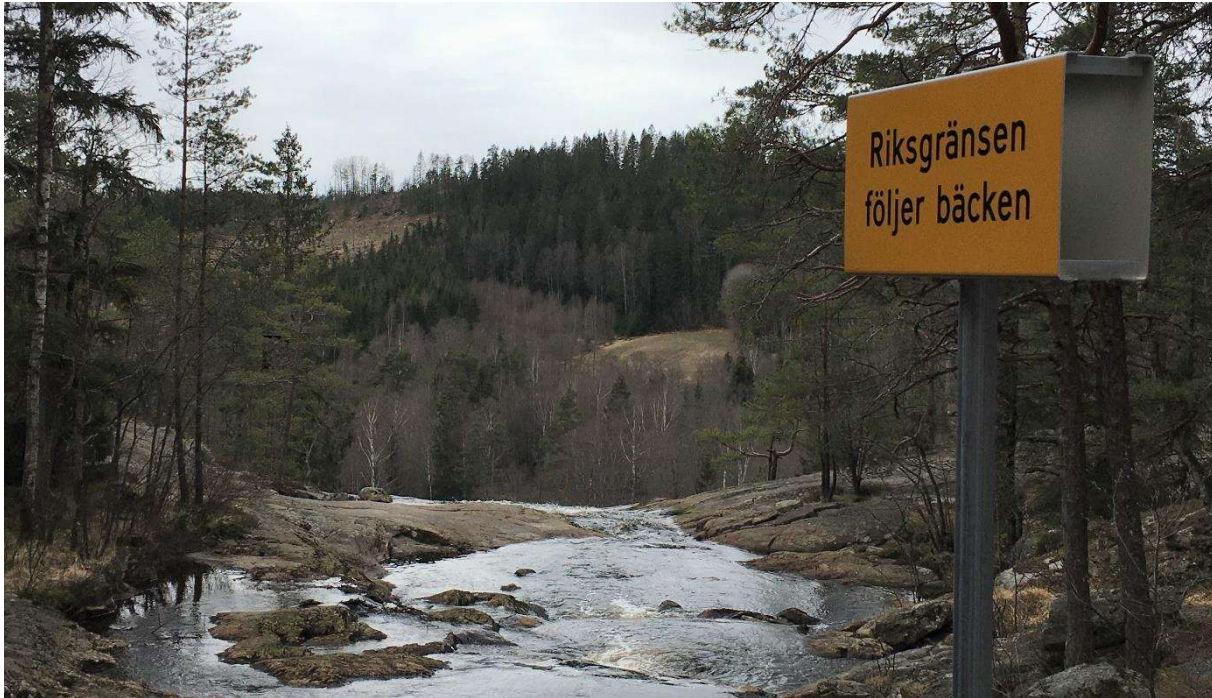
**Figure 3:** *In some parts, the boundary line runs along creeks, occasionally indicated by sign posts saying that the boundary line follows the creek (“Riksgränsen följer bäcken”).*

To reduce the distance between neighbouring boundary markers, the number of boundary markers has increased significantly during the reviews carried out in the 20th century. Some new boundary markers have also been erected to replace creeks with straight lines. The remaining parts where the boundary line passes through lakes or runs along watercourses (mainly creeks) are approximately 76 kilometres long, see Figure 3.

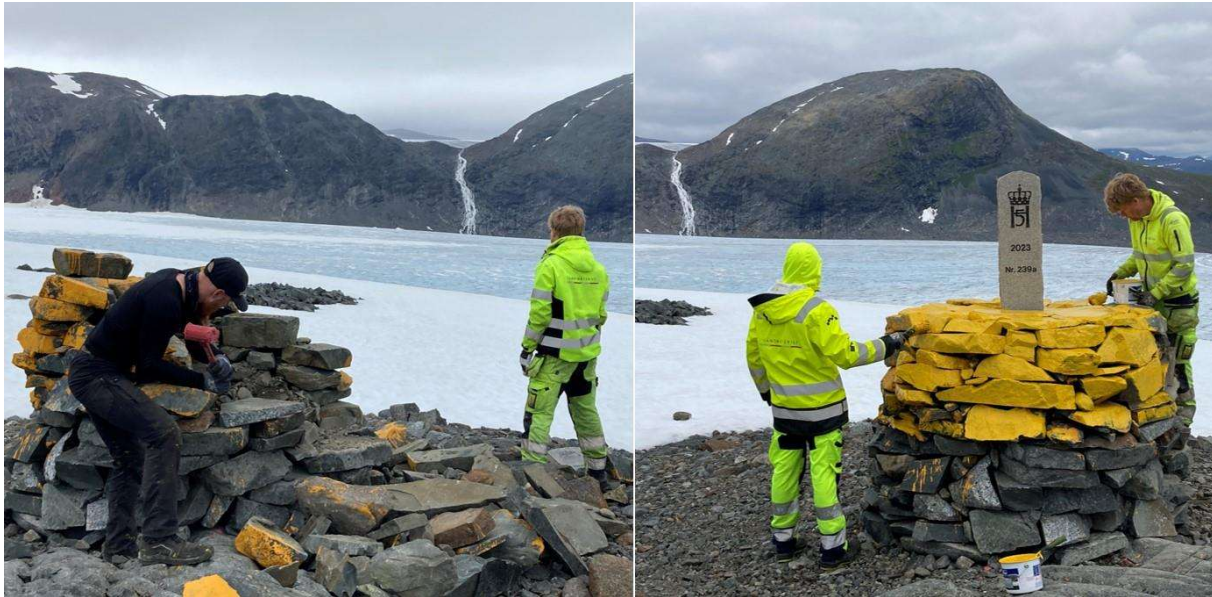
**Figure 5:** Boundary marker no 239a had by snow and hard weather been destroyed including the flat stone with the engraved royal monograms and the need for restoration was huge.

The field work during the review of the national boundary between Sweden and Norway 2020–2024 has been extensive, see Figure 5:

- All boundary markers and other markers were cleaned and if necessary restored (a rough estimated is that over 1000 tons of stones were lifted by hand).

- The upper part of all stone cairns was painted yellow (a rough estimate is that around 3000 litres of paint have been used).
- The engraved royal monograms were filled in with black paint.

- 18 flat stones with the engraved royal monograms were found broken and they were replaced with newly produced ones, bearing engraved royal monograms of the Swedish King Carl XVI Gustaf and the Norwegian King Harald V.

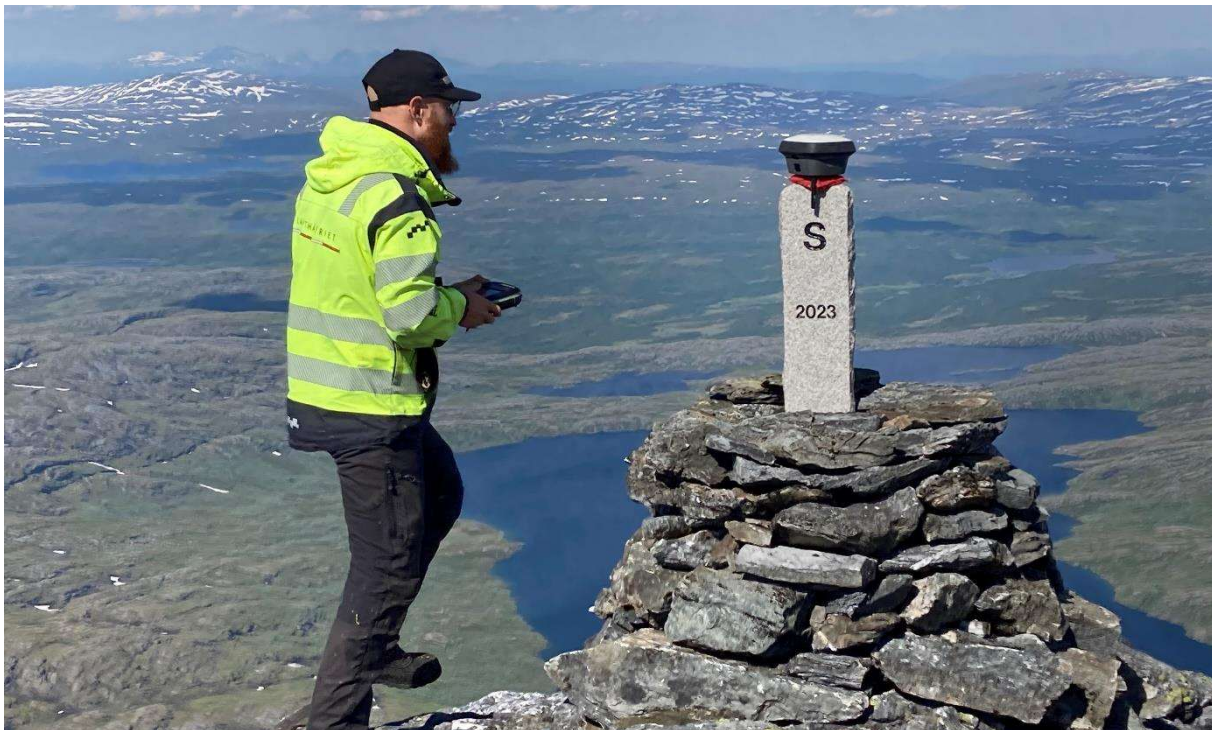
**Figure 6:** A small stone cairn as a boundary marker that do not define the boundary has been erected on the highest point along the boundary (1752 metres above mean sea level), here surveyed with network RTK by Swedish field engineer Karl Tirén.

The GNSS-based network RTK services from Lantmäteriet (Swepos) and the Norwegian Mapping Authority (CPOS) were mainly used for staking out the boundary line and for measuring the boundary markers, see Figure 6. Since mobile Internet connection was partly inexistent, post-processing was used in these areas, either through static measurements or through processing with virtual RINEX files. In some areas, also single-station RTK was used. The boundary markers that define the boundary were for redundancy reasons measured three times with at least 15 minutes separation between each measurement.

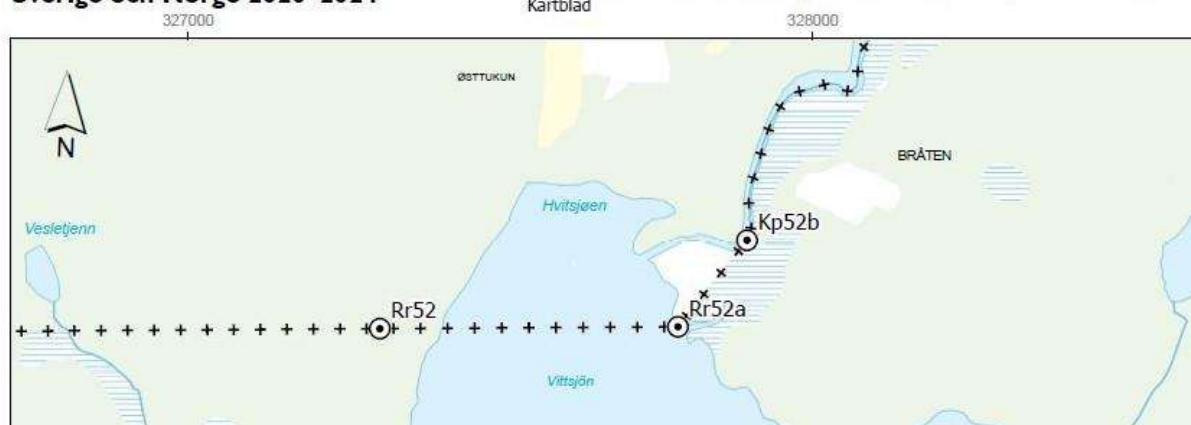
**Figure 7:** The boundary line goes as a straight line from boundary marker no 52 to 52a where a new stone cairn has been erected and then as a straight line to a point defined by coordinates (52b) in a creek, which the boundary line from there on follows northwards.

The review of the national boundary between Sweden and Norway 2020–2024 is the first one where the official documentation will be digital. All information about the boundary is available in a digital file that is created in the format Geography Markup Language (GML). The file will be the official documentation for public use until the next review in about 25 years. It contains the various boundary markers with coordinates and their respective locational uncertainties. It is also the basis for other documentation that visualise the central information in the GML file, such as a text-based description of the boundary, individual descriptions with photographs of each boundary marker and maps of the boundary's stretch in lakes and watercourses, see Figure 7.

The new digital representation of the boundary also leads to a need for clear definitions of the boundary line in its transition from lakes to creeks and to straight lines. Until now, both the maps showing the boundary line in creeks and lakes from the review 1959–1962 and the text documentation from the review 1984–1987 are occasionally a bit unclear in this sense. Joint field visits at these locations by members of the two boundary commissions have therefore been needed. The result is a clear definition of the boundary in all locations. The stretches of the watercourses have also been controlled. In a few locations, there have been a need to define break points with coordinates and in one location a new boundary marker that defines the boundary has been erected, see Figure 7 and 8.

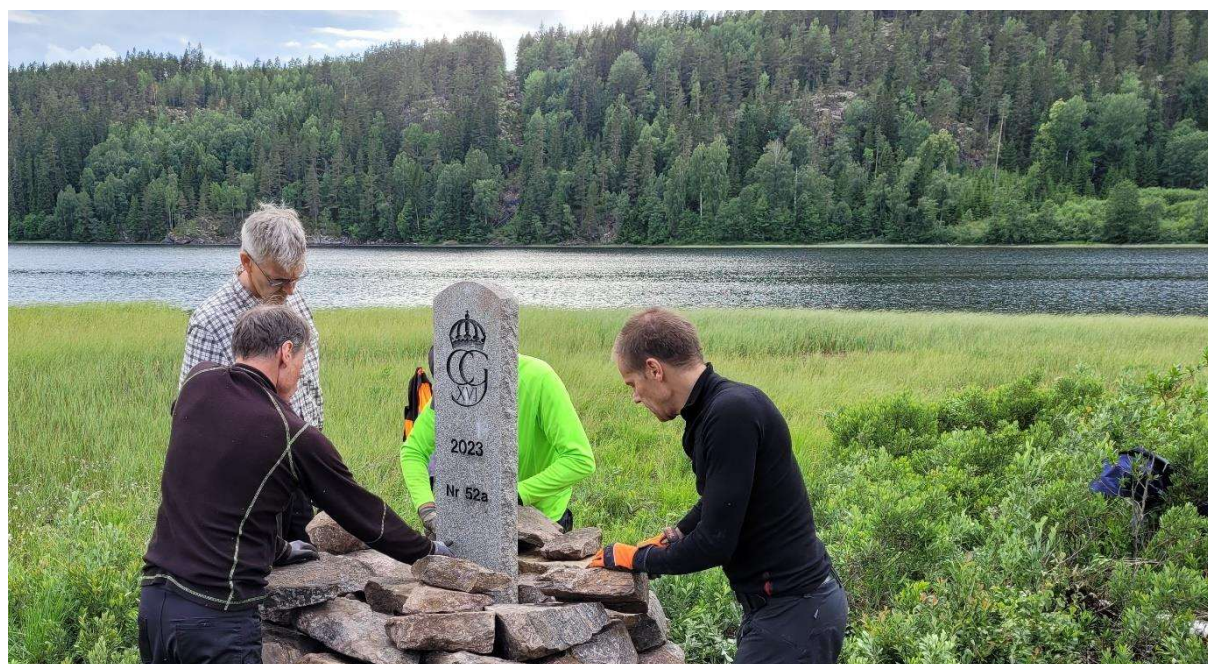
**Figure 8:** One new boundary marker that defines the boundary has been erected during the review of the boundary 2020–2024. The work with building the cairn was performed through joint efforts by Tor Erik Bakke, Anders Østeraas, Martin Lidberg and Dan Norin from both boundary commissions. The boundary marker is designated 52a and the location is in a break point that so far only has been defined in earlier maps. Boundary marker no 52 is visible on the other side of the lake in the boundary clearing.
