HORIZONTAL DEFLECTION ANALYSIS OF A LARGE EARTHEN DAM BY MEANS OF GEODETIC AND GEOTECHNICAL METHODS

Vassilis GIKAS[1], Michael SAKELLARIOU[2]

13th FIG Symposium on Deformation Measurement and Analysis
4th IAG Symposium on Geodesy for Geotechnical and Structural Engineering

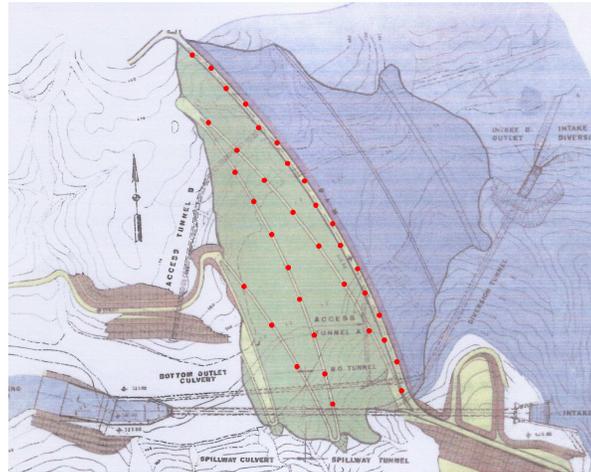
The deformation monitoring system of the dam comprises various types of instruments (piezometers, magnetic extensometers, accelerometers, etc.). The geodetic monitoring system consists of two principal geodetic control networks. The main network was established in early 1976 for monitoring the greater area and the embankments of the dam. It consists of 15 reference stations, the locations of which were specified by geologists and civil engineers (Mitsakaki and Stathas, 1983). As shown in Figure 2, the length of the sides of the network varies between 0.3 km and 2.5 km. A more dense geodetic control network was established along the crest of the dam, on the downstream face and the abutments. In total, 53 control stations were established to monitor the deformation of the dam body (Figure 3).

Figure 3- Geodetic control points at the crest and downstream abutment

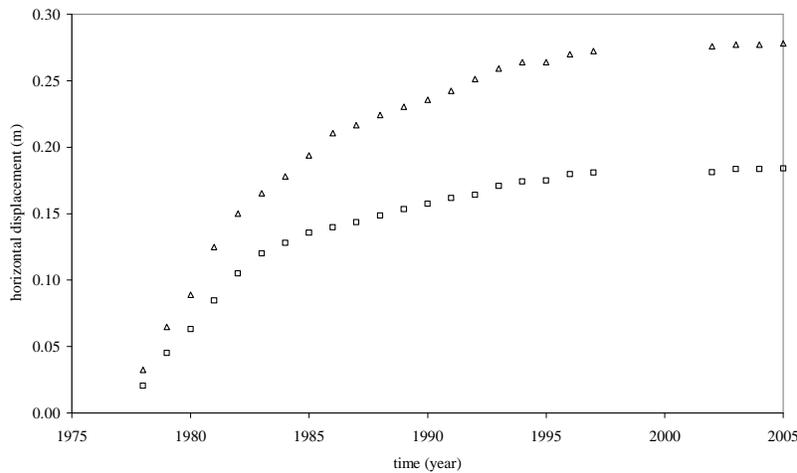
Figure 4- Accumulated horizontal displacements at control stations S21 (at the middle) and S32 (near the tail-end) of the dam

Analysis of the deformation monitoring data at the control points of the main geodetic network reveals that the horizontal displacements are statistically significant - howbeit, they exhibit rather small velocity vectors (~2 mm/year). On the contrary, the horizontal deflections observed at the crest of the dam result in much larger movements, which are aligned on the upstream-downstream direction. Figure 4 shows the progression of horizontal displacements of control points S21 and S32, which are located at the middle and towards the tail-end of the crest. From this plot it is evident that maximum displacements occured rapidly during the post-construction period of the dam with a tendency of stabilization in more recent years.

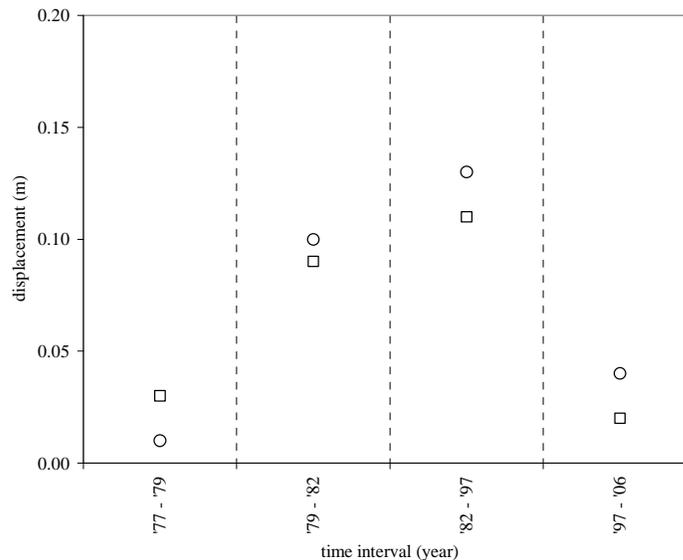
Figure 8 - Horizontal displacements (η-component) at cross-section 6 (middle of the dam) estimated by geodetic observations and FE modeling. The periods 1979-1982 and 1982-2006 correspond to the stages of first filling of the reservoir and operation of the dam

Figure 8 shows the horizontal displacements (η-component) at cross-section 6 (located at the middle of the crest) obtained by FE modeling and geodetic monitoring. From this plot it is evident that the overall difference for a total period of 28 years is in the order of 2 cm. Furthermore, the symmetry of the deflection patterns observed between the various stages in the lifetime of the dam are similar, suggesting that, the assumptions made and the parameters (material type, boundary conditions, etc.) used in the FE modeling are correct.

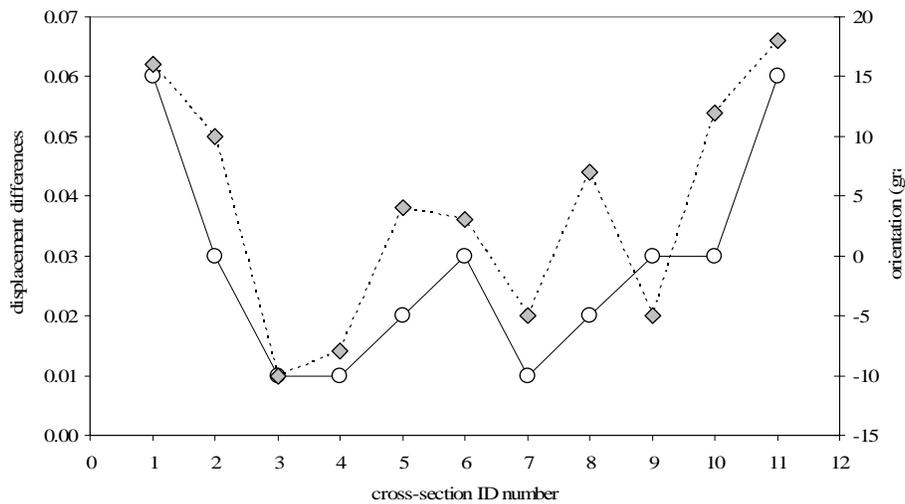
Figure 9 depicts summary results derived by the FE analyses and the geodetic monitoring observations at the eleven cross-section locations. More specifically, it shows the differences between the two estimates in the accumulated horizontal movements (circles) in the time period 1979 - 2006, and the deviation in the orientation of the geodetically derived displacement vectors (rhombs) from the upstream-downstream direction for the same period of time. From this graph it is obvious that the differences in the magnitude of the displacements are small and vary from 1 cm - 3 cm. The relatively higher (6 cm) values observed towards the tail-ends of the crest are most likely to occur due to the assumptions pertaining to the two-dimensional plane-strain conditions used in the FE models. Also, as expected, the horizontal movements are pointing strongly downstream normal to the crest of the dam due to the loading by the reservoir. Overall, these results add further confirmation that the geodetic procedures followed and the implementation of the FE models are correct.

Figure 9 - Differences in the horizontal displacements computed for the eleven cross-section locations at the crest of the dam between geodetic monitoring and FE modeling (circles), and deviation in the orientation of the geodetically derived displacement vectors from the upstream-downstream direction (rhombs) for the period 1979-2005
